**AIRCRAFT SHELTER EXPLOSIVES
QUANTITY-DISTANCE EVALUATION,
CONCRETE SKY, PHASE IXB**

TECHNICAL REPORT NO. AFWL-TR-71-65

July 1971

AIR FORCE WEAPONS LABORATORY

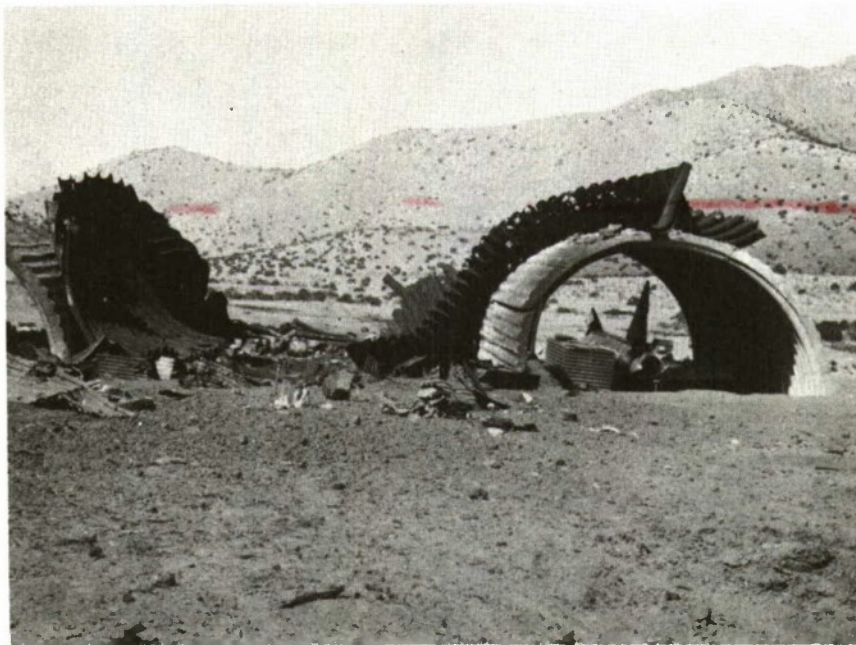
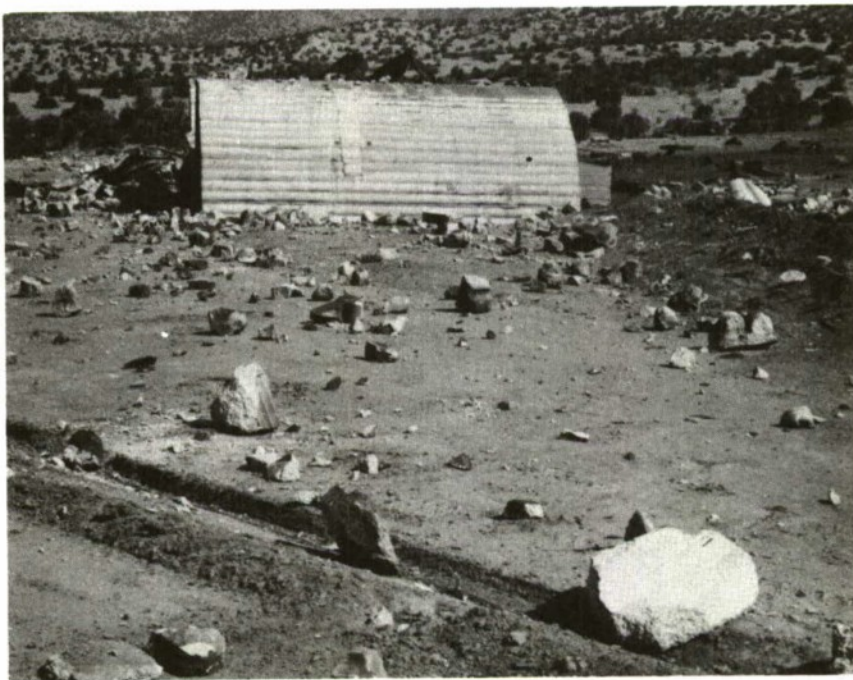
Figure 11. Destruction of Donor Shelter

The donor shelter was completely destroyed during the test. Blocks of the concrete cover, ranging from pebble size to 6-by-6-foot pieces, were found over a large area. The steel arch material was broken primarily into large blackened, twisted pieces that were peeled back against the sides of the acceptor shelters. The major pieces were similar in size. High-speed photography showed that the

concrete was thrown off in a pattern roughly symmetrical about the longitudinal centerline of the shelter at initial trajectories along radial lines from the center of the blast. The fireball quickly covered the shelters so that actual failure of the donor could not be seen. However, it is apparent from the above that rupture first occurred near the top rear of the shelter. The smooth appearance of the faces of the blocks of concrete where they had been in contact with the steel arch indicated that little, if any, bond had existed between the two materials. The lack of bond also accounted for the fact that the concrete began separating from the steel very quickly after the detonation. Various aspects of the failure of the donor are illustrated in figure 11.

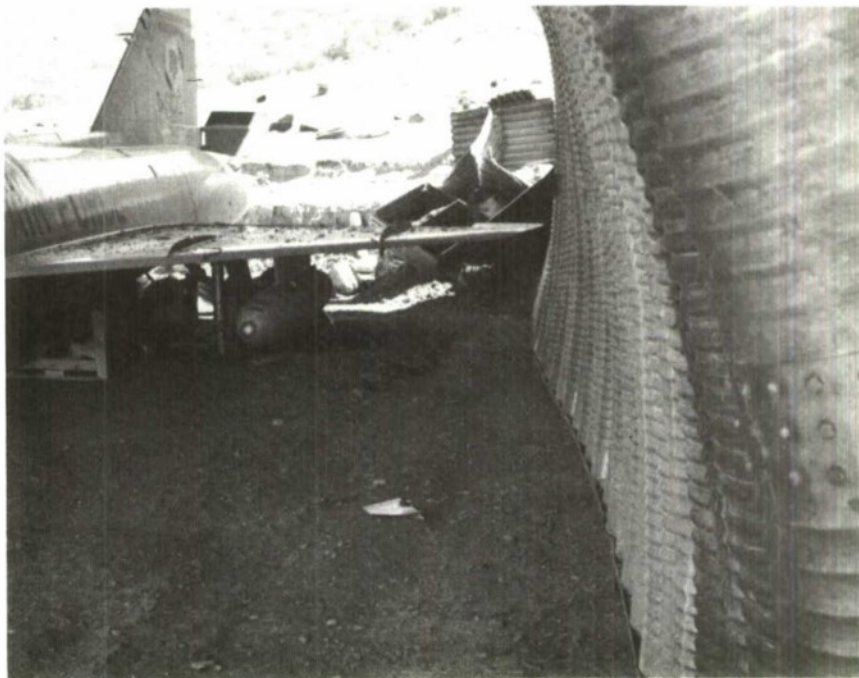
Figure 12. Displacement of Wall in Shelter A

Neither acceptor shelter collapsed during the test event, although some damage was sustained by both. Shelter A, which did not have the added protection of a revetment separating it from the donor, sustained a greater amount of damage than shelter C did. The most significant damage was the displacement of the wall adjacent to the donor in toward the centerline of shelter A (figure 12). The distance the wall moved varied from almost no displacement at the front of the shelter to a 6-foot displacement at 20 feet from the rear of the shelter, then tapering to a 4-foot displacement at the rear. The location of the maximum displacement corresponded to the location of the bombs in the donor shelter so that the main force of the explosion was concentrated in this area.

It is important to note that both acceptor shelters would still have been usable if combat conditions dictated their continued use. Shelter A would have required extensive repairs to prevent further weakening from future blasts in its vicinity. Shelter C would have been immediately usable with little or no repair.

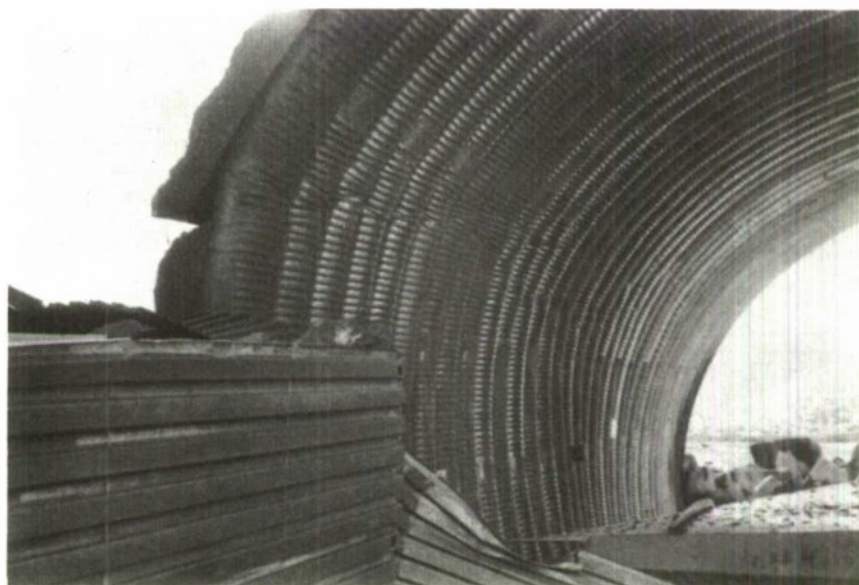
Figure 13. Hinging of Acceptor Wall (Shelter A)

Associated with the displacement of the base of the wall was the hinging action seen in figure 13. This figure illustrates the separation of the concrete on the exterior and crimping of the steel arch on the interior of the shelter. This damage and the extensive cracking of the exterior of shelter A are shown in figure 14. It was noted that most cracks occurred along vertical lines of form bolts and along horizontal cold joints. (Note that cold joints in the construction also occur at horizontal lines of form bolts, therefore further weakening these areas.)

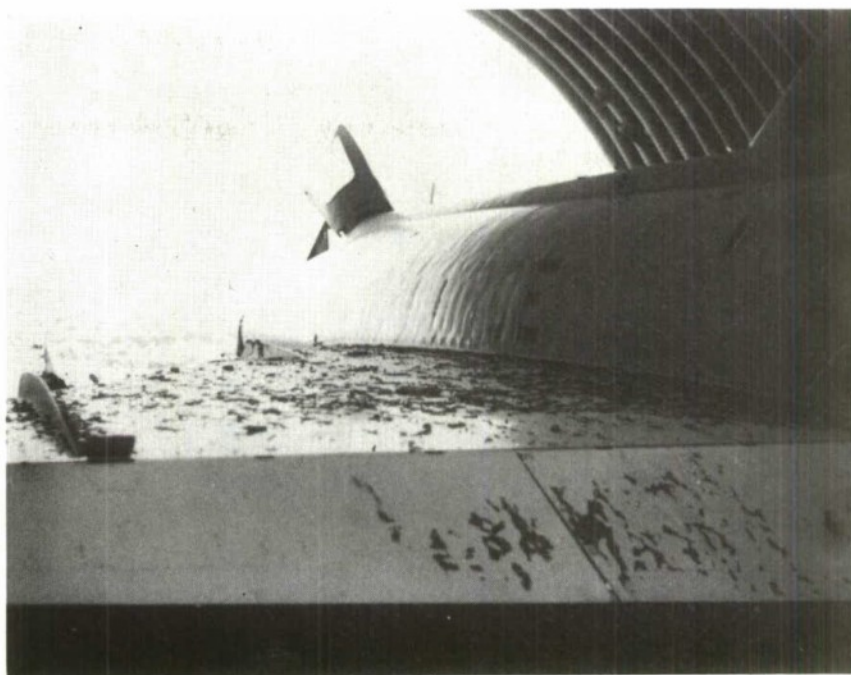
Figure 15. Skin Wrinkles on Fuselage

Damage to the acceptor aircraft was considered light. Some types of damage were common to both aircraft, such as wrinkling of the skin on the fuselage (figure 15), partial detachment of the tail cone, and destruction of the antenna at the tip of the vertical stabilizer (figure 16).

The acceptor aircraft were later inspected by personnel experienced in the aircraft maintenance, operations, structural design, and vulnerability assessment fields. The opinions of these experts were substantially the same, that the aircraft were in flyable condition as they stood. The operations personnel contacted stated that they would not hesitate to fly the aircraft if combat conditions dictated it. The damage sustained would prevent maximum performance, but would not prevent completion of scheduled missions. At most, minor repairs would be necessary. All observers stated that it would be preferable, but not essential, to make a more thorough inspection before returning the aircraft to service if time permitted.

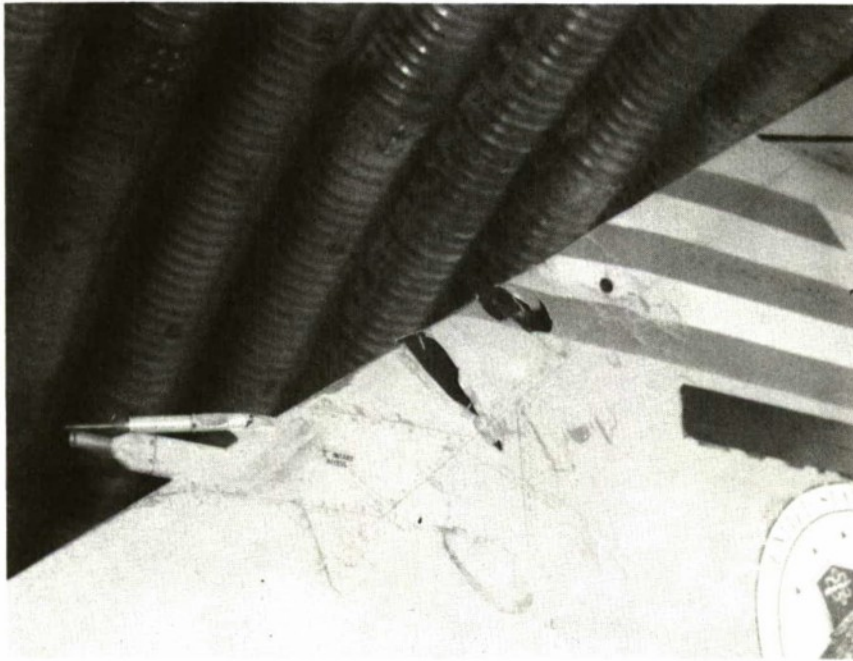
Figure 17. Tail Damage to Acceptor Aircraft A

Acceptor aircraft A had several holes that at first appeared to be caused by shrapnel. The lacerations in the leading edge of the vertical stabilizer (figure 17) are typical of this type of damage. A search for fragments of

shrapnel in the shelter was fruitless, but several pieces of debris from the rear revetment were scattered throughout the shelter. Further checking of the holes showed no signs that the penetrating fragment was hot, lending credence to the speculation that the holes were caused by simple flying debris rather than shrapnel. Note also in figure 17 the scratch marks in the vicinity of the holes. It is thought that these were caused by debris deflecting off the surface, possibly attached to the pieces that penetrated the leading edge.

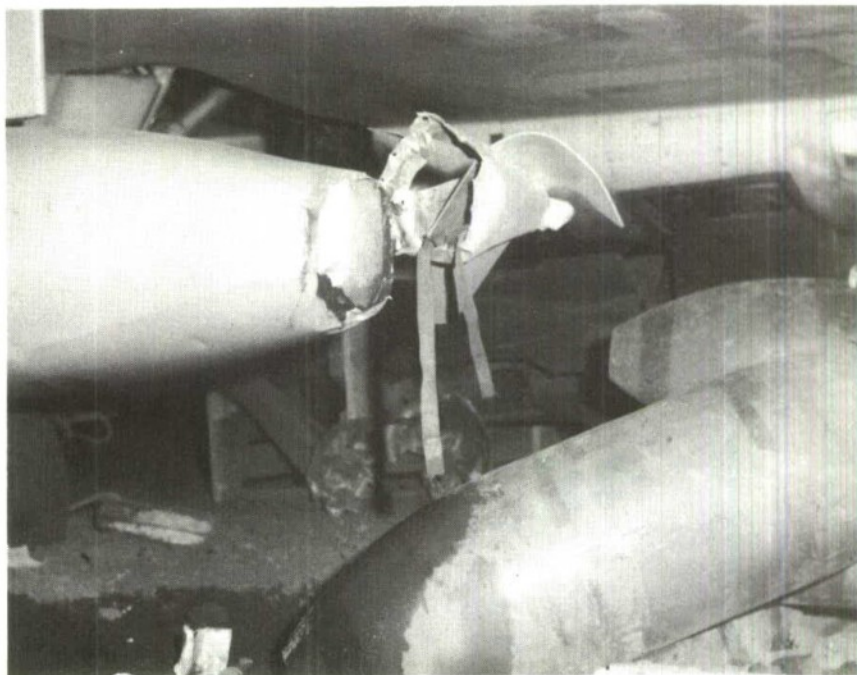
Figure 18. Damage to External Fuel Tank

The tail of the left external fuel tank on aircraft A was sheared off (figure 18), which resulted in a slight fuel leak from this tank. Again, this had the outward appearance of shrapnel damage, but none was found. This was probably caused by the same type of debris cited above. Further, shrapnel penetrating this area would likely have ignited the fuel, which did not occur. Figure 18 also illustrates the partial displacement of a portion of the bombs under aircraft A. The displacement is further shown in figure 19. Note also the damage to the tail fins of the bombs. This apparently was caused by the overpressure from the explosion in the donor shelter, as no evidence was found to indicate they had been hit by flying debris.

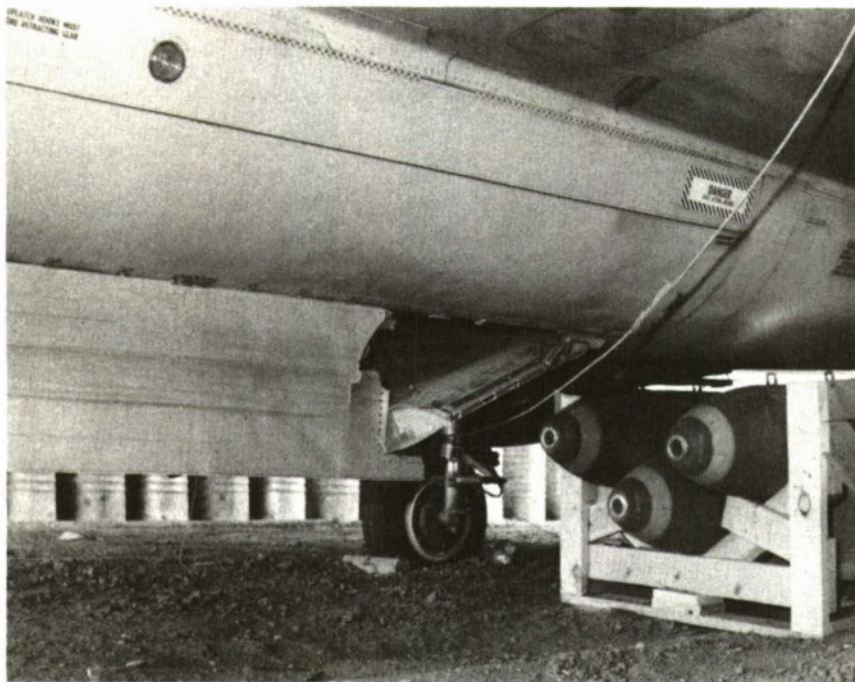
Figure 20. Armament Bay Door Damage

On both acceptor aircraft, the armament bay doors were damaged, although this type of damage was greater on aircraft C. The mode of failure seems to be a tearing of the structure of the door (figure 20). This was caused by a

partial failure of the hydraulic actuators that operate the doors. However, the significance of this damage is questionable since the F-4 does not have this type of door.
